# Analysis of 19<sup>th</sup> Century Boat Anchor Using Field Metallography Techniques

## Class 1

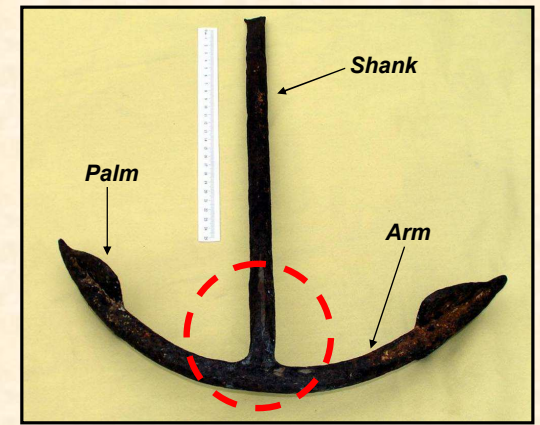
Figure 1 – Image of the as-received anchor. Circle indicates region of analysis. 0.03x

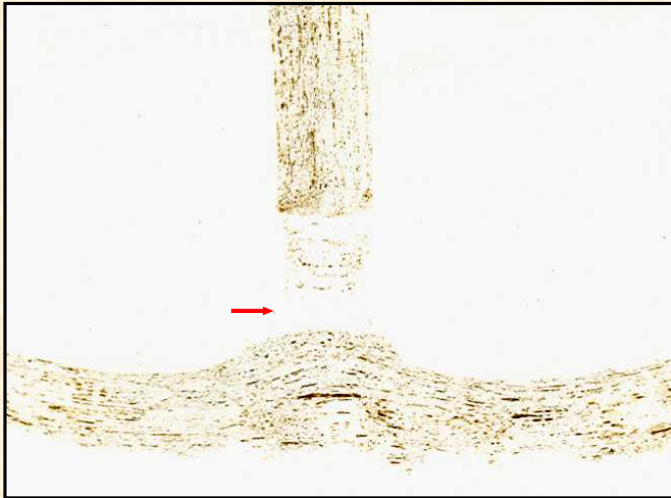
Figure 2 – Sulfur print of joint between shank and arms. Reaction between the treated photo paper and sulfur in the anchor produces the contrast seen here, indicating slag inclusions are sulfur rich. Note curvature of slag inclusions at joint, indicating this region was forged to prepare for joining to shank. Note region (red arrow) that is relatively sulfur free. 1x

**Results:** After completion of final polishing, it was evident that the anchor contained a high concentration of slag inclusions (Figures 2 and 3), aligned with the long dimensions in the anchor, indicating that the anchor was wrought. Note also the region near the shank-arm joint that is relatively free of inclusions. Preparation of thin film replicas of these inclusions (Figure 3) did not reproduce their fine substructure accurately. Consequently, the entire anchor was placed on the microscope stage and images of the slag inclusions were taken. These were found to have a dendritic substructure (Figure 4). While most of the anchor's shank that was analyzed exhibited only ferrite, the region between the shank and arms that was free of inclusions (red arrows, Figure 2) was found to contain pearlite (Figure 5). Whether or not the presence of pearlite in this area was intentional is not known. However, pearlite was also found during analysis of the joint between the arm and palm (not shown), indicating that carbon was added in the regions where two pieces were to be joined. Additionally, mechanical twins were found in the replica prepared from the anchor's shank (Figure 6). These twins may have been created during the manufacture of the anchor, or by overstressing the anchor during use.

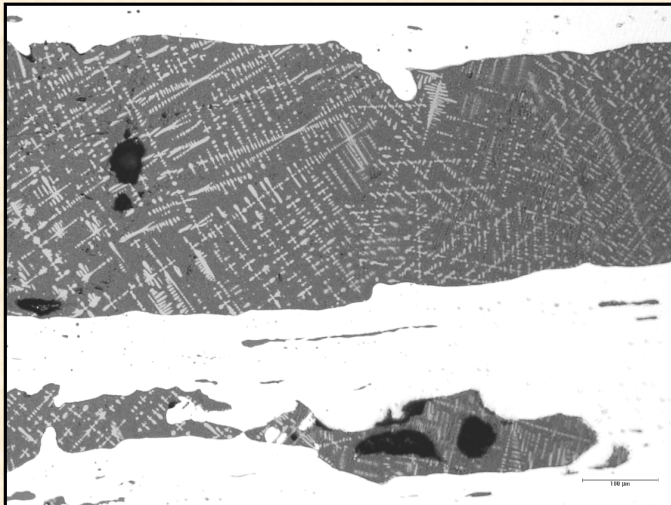
Figure 4 – Light optical micrograph of as-polished slag inclusion – image was taken by carefully balancing anchor on microscope stage. Note presence of dendrites within slag inclusion. 25x

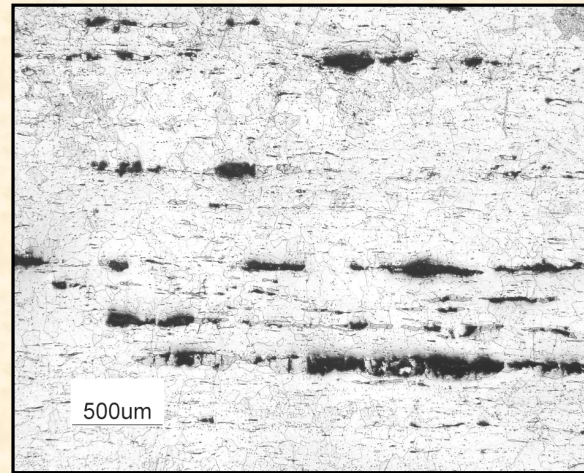
Figure 3 – Light optical micrograph of thin film replica prepared from arm region. Note texture of slag inclusions, along the long axes of anchor, indicating this piece was wrought. 10x

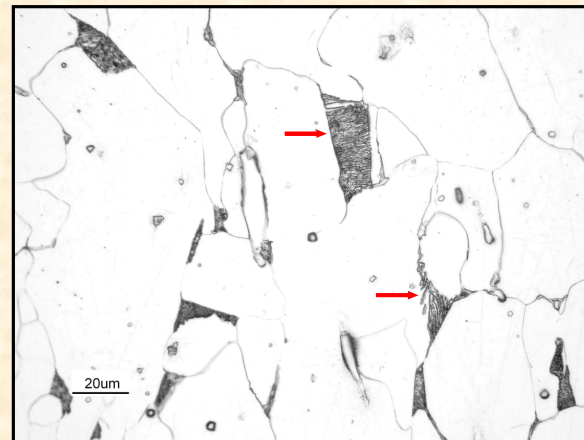
Figure 5 – Light optical micrograph of replica taken from anchor shank, near joint with arm. Pearlite (red arrows) was found in the same inclusion-free region between shank and arms. 94x

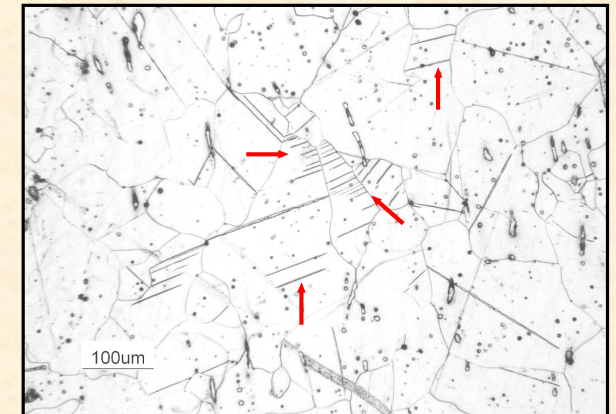
Figure 6 – Light optical micrograph of replica taken near shank and arm joint showing mechanical twins (red arrows). The origin of these twins (manufacture or use) was not determined. 23x
